Intel® Mobile Pentium® III Processor Specification Update

Release Date: November 2000

Order Number: 245306-013

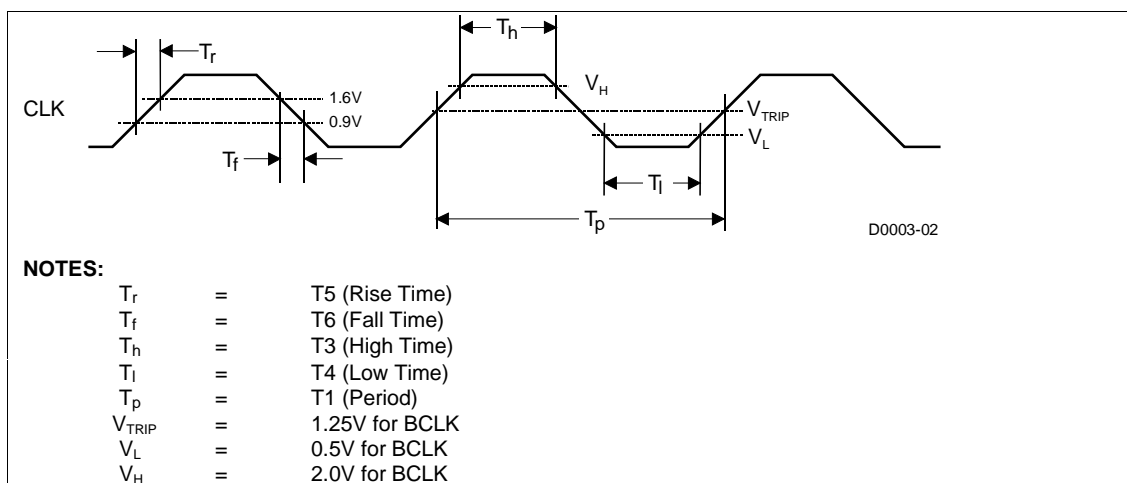
Figure 7. BCLK Timing Waveform

Symbol	Parameter	Min	Typ	Max	Unit	Figure	Notes
	System Bus Frequency		100		MHz		
T1	BCLK Period		10		ns	Figure 7	Note 2
T2	BCLK Period Stability			± 250	ps		Notes 3, 4
T3	BCLK High Time	2.70			ns	Figure 7	at >2.0V
T4	BCLK Low Time	2.45			ns	Figure 7	at <0.5V
T5	BCLK Rise Time	0.175		0.875	ns	Figure 7	(0.9V – 1.6V)
T6	BCLK Fall Time	0.175		0.875	ns	Figure 7	(1.6V – 0.9V)

1. All AC timings for GTL+ and CMOS signals are referenced to the BCLK rising edge at 1.25V. All CMOS signals are referenced at 0.75V.
2. The BCLK period allows a +0.5 ns tolerance for clock driver variation.
3. Not 100% tested. Specified by design/characterization.
4. Measured on the rising edge of adjacent BCLKs at 1.25V. The jitter present must be accounted for as a component of BCLK skew between devices.

For B0 step processors, the $V_{IH,BCLK}$ Min spec is changed to 2.0V (from 1.7V for A2 step) and $V_{IL,BCLK}$ Max spec is changed to 0.5V (from 0.7V for A2 step). Due to this, new values are specified for BCLK high and low times for B0 step processors. These modifications affect corresponding specs in Table 13, Table 14, Table 24, and Figure 7 in *Mobile Pentium® III Processor in BGA2 and Micro-PGA2 Packages datasheet* (Order Number 245302-002).
